Eren Energy Power Plant FGD Stack Relining

Case history 2015

Focus product: Ceilcote® 282 HB @ 2 x 650µm (26 mils)

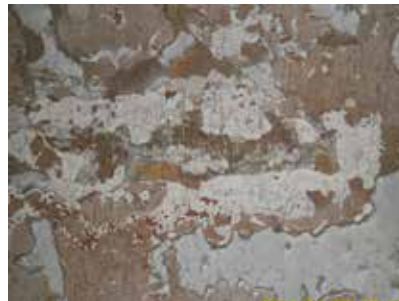
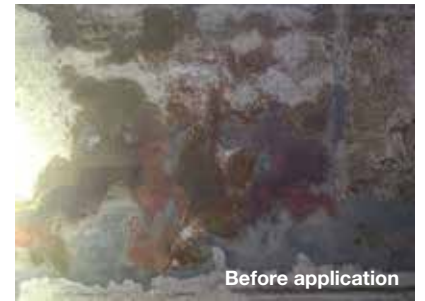
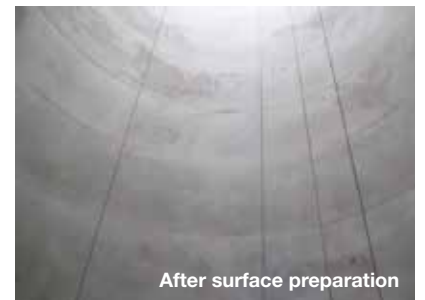
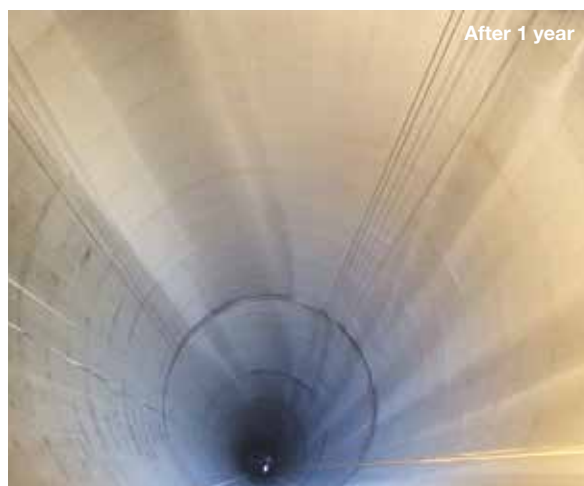
FGD Stack lining area Inspection/Interplan™ carried out at Eren Energy Power plant on April 2014. High corrosive activity, blistering failures and detachment failures observed on 6,500m² FGD stack walls Internal surfaces.

After one year, first corrosion inspection performed by AkzoNobel Protective Coatings Technical Service on May 2015. These pictures show the coating was still very well after one year in service and there was no evidence of corrosion. This practically demonstrates the abrasion, chemical and heat resistance of Ceilcote 282HB in a coal power plant (FGD Stack) environment.

Ceilcote 282HB application carried out at the Eren Energy Power Plant in Turkey/Zonguldak. Surface preparation and lining application inspected and reported by AkzoNobel Protective Coatings Technical Service. Relining of FGD Stack completed on May 2014.
