GAD tank lining

Case study 2015

Focus products: Intercrete® 4872 and Interline® 975

Location: Turkey

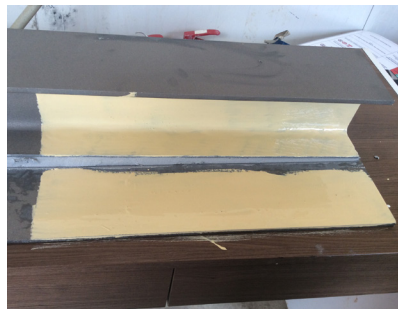
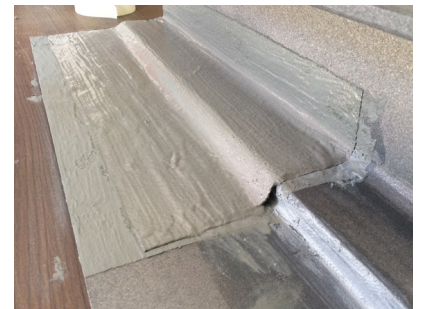
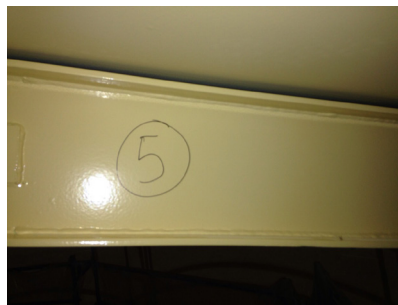
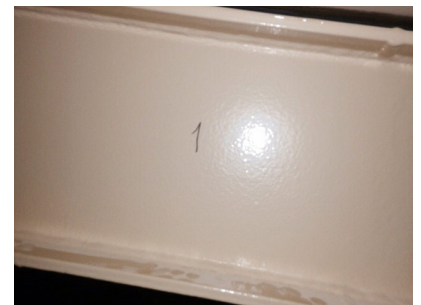
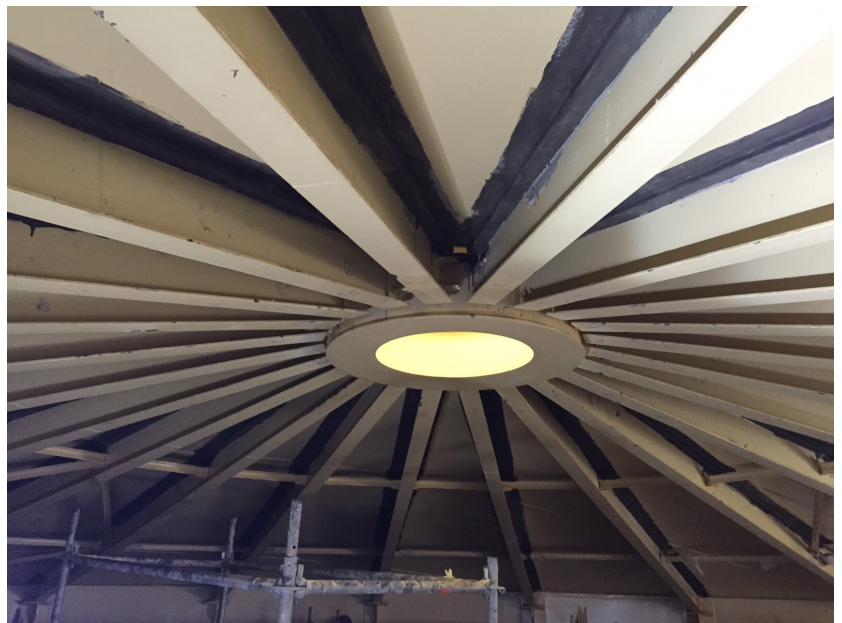
An Interplan® inspection carried out at CCPP Power plant on August 2015. Design failures observed between tank roof internal steel supports and roof plates as seen in photos.

It was reported about problem and issue on the roof support construction of the tank. There are gaps between support structures and roof plates, which were not possible to properly fill with coatings. These gaps may lead to premature coatings failure due to crevice corrosion. To prevent such case we would like to advise Intercrete tape application, below system;

Surface preparation: SSPC SP11 – corroded areas (roughening with coarse sand papers on to Interline 975 applied surfaces).

MR system: Intergard® 821 to fill gaps between supports and roof plates.

For tape application: Intercrete 4840 epoxy copolymer primer.

Intercrete 4872 tape.

Intercrete 4842 polymer modified elastomeric cementitious coating.

Corrosion risk of desing failure were taken under control by coating with Intercrete 4872 tape system. Customer and applicator were satisfied about application and technical trainee of Intercrete 4872 tape sealing system.
