# Spill Water Tank

## Case study

**Summary:** Protection of steel spill water tank for the Swedish Yeast Company

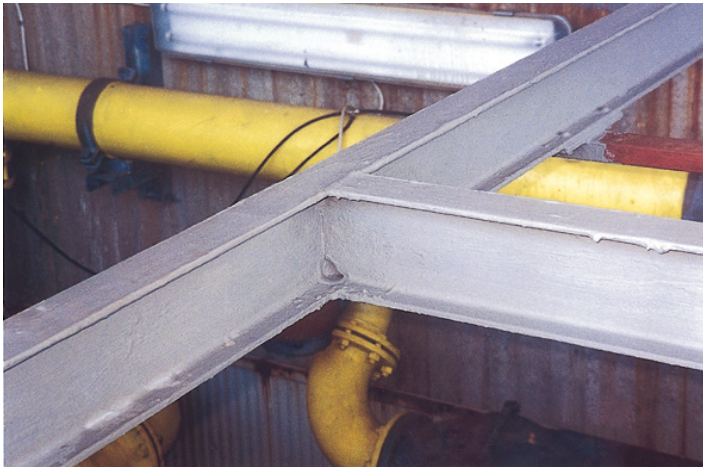
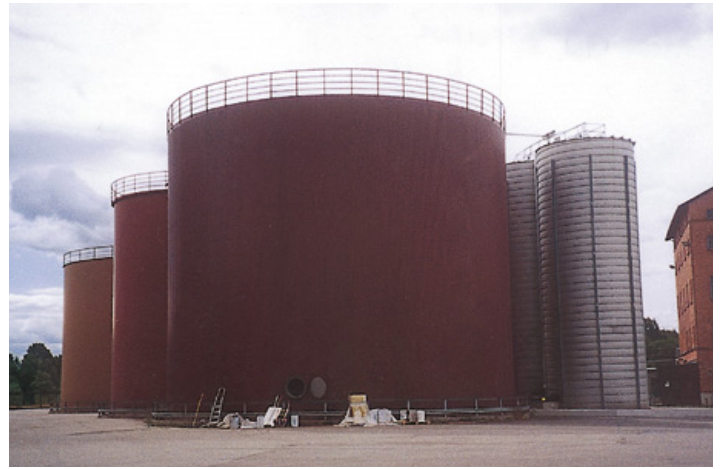
The steel spill water tank belonging to The Swedish Yeast Company was showing evidence of corrosion internally both on the floor and structural support beams.

In selecting Intercrete 4840, it was possible to benefit from the latest corrosion control techniques without the restrictions attached to handling hazardous chemicals in a confined space. With surfaces prepared using a combination of grit blasting and needle gunning, spray equipment was used to install a 2mm layer of Intercrete 4840 directly on the bare metal to provide 'stand-alone' protection. Tested in the most onerous of conditions, the performance of Intercrete 4840 is such that it forms a true barrier to the fuels for corrosion, blocking out water, chlorides and oxygen. Passivation is additionally provided through the dual mechanism of inherently high alkalinity and the action of anodic inhibitors which are comprised in the unique formulation.
