Guangzhou Datansha No.5 pump station

Case study 2012

Focus products: Intercrete® 4801, Intercrete® 4840

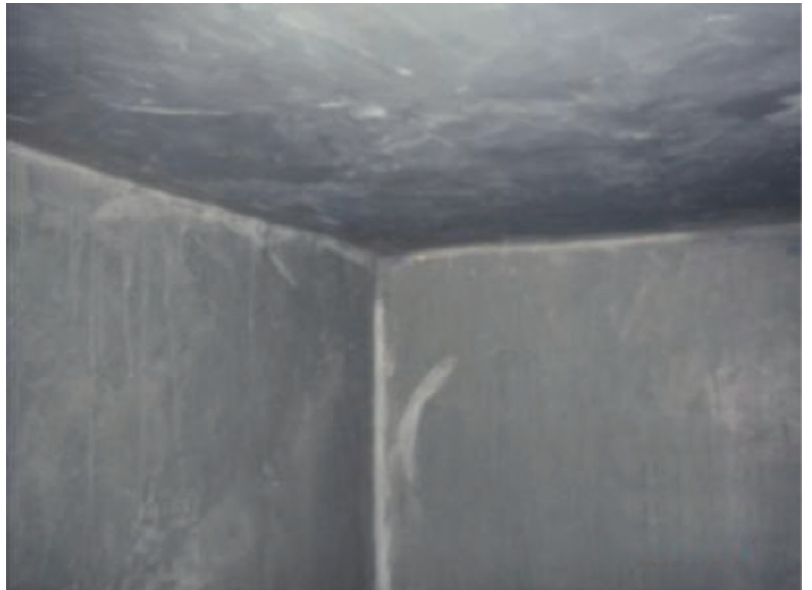
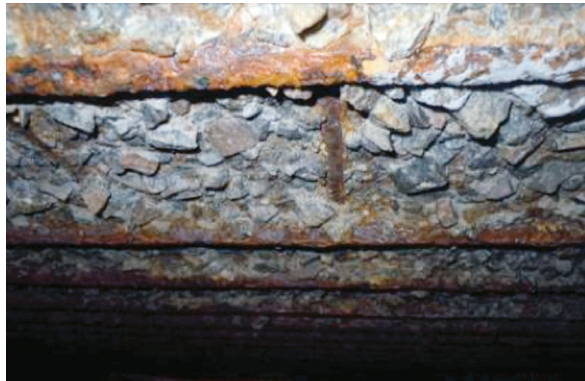
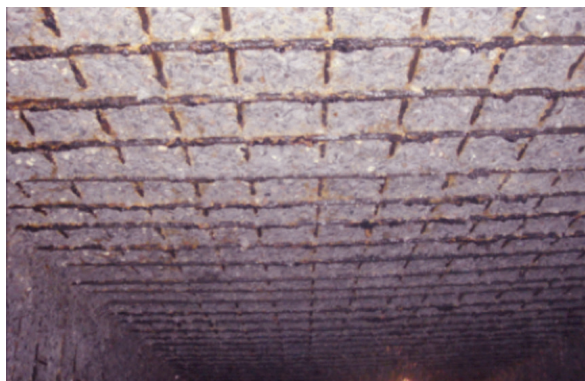
Concrete is vulnerable in a waste water environment. Without protection chemicals attack the concrete matrix causing premature degradation of the substrate which can then lead to costly and disruptive repairs. The concrete in Guangzhou Datansha pump station was severely eroded after just 6 years in service.

A repair and protection solution was urgently needed. However due to its central location, cost of shutdown was approximately 900,000 CNY (€109,000) per day to the local authority. Access and ventilation were a problem making it impossible to dry the concrete sufficiently to apply a conventional coating system.

Intercrete provided the complete solution. Intercrete 4801 is a high build repair mortar that allowed the applicator to reinstate the damaged concrete rapidly in a single layer, most competitor materials would require at least two. Intercrete 4840, a water-based high performance cementitious coating, was applied directly onto the damp substrate to provide a long term protective solution.
