Fosfertil Prill Tower

Case study

Summary: Reinstatement of cover to steel reinforcements inside Prill tower

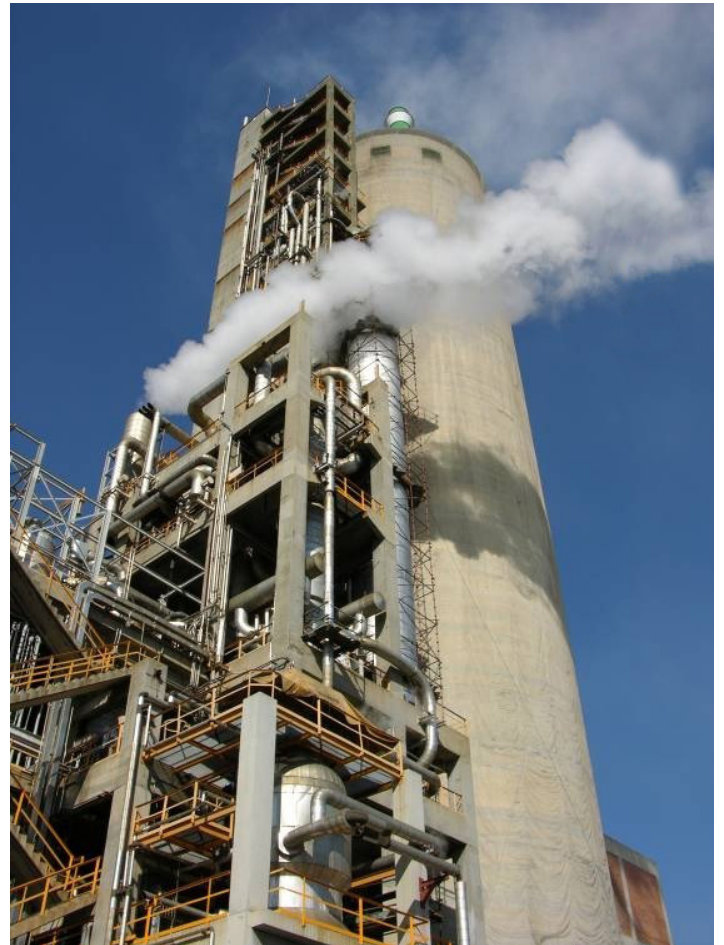
Fosfertil is Brazil's largest producer of raw materials used in fertilisers. At this plant, urea is deposited down a tower to form pellets. This results in a hot and chemically aggressive atmosphere which quickly attacks normal concrete to cause spalling and corrosion of the steel reinforcement. The worst areas were recorded in the top 15m of the 100m tower where the concrete cover was almost completely eroded.

The urea deposits which had accumulated on the prill tower were mechanically removed. All exposed steel reinforcement was protected with Intercrete 4871 and concrete repairs to the heavily damaged areas in the top section of the tower were undertaken with Intercrete 4801, chosen for its high build characteristics. The workers abseiled down the tower in order to spray-apply Intercrete 4840, an epoxy cementitious coating, which is applied directly to the concrete. Intercrete 4840 was selected to give long term protection against abrasion and chemical attack from the urea.
