# Weiser Wastewater Treatment Plant

## Case study

**Summary:** Waterproofing of concrete aeration basin and sealing of leaking kicker joints

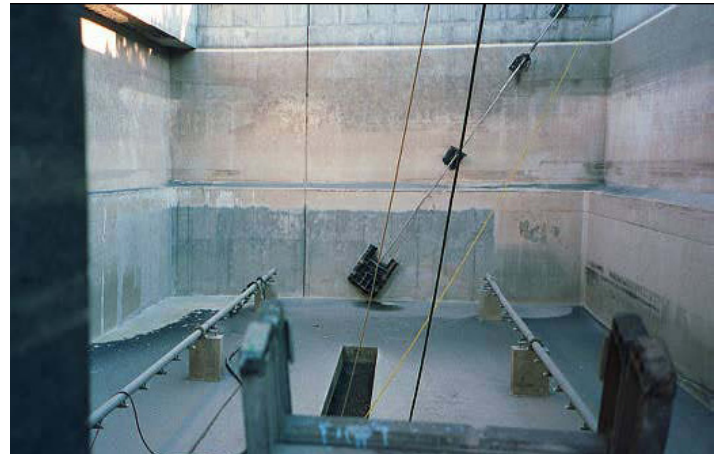
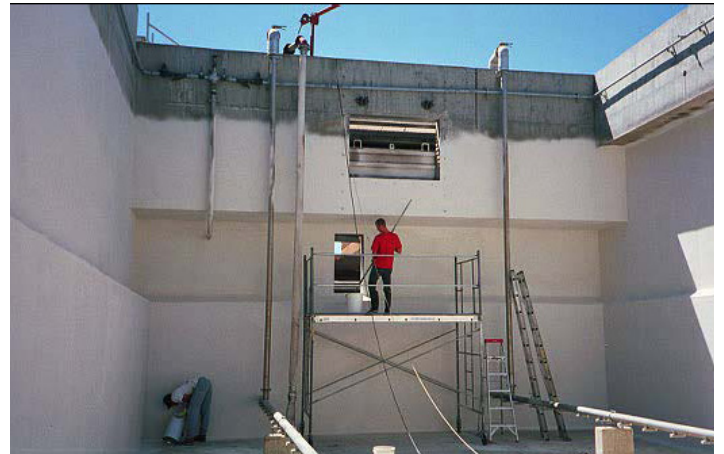
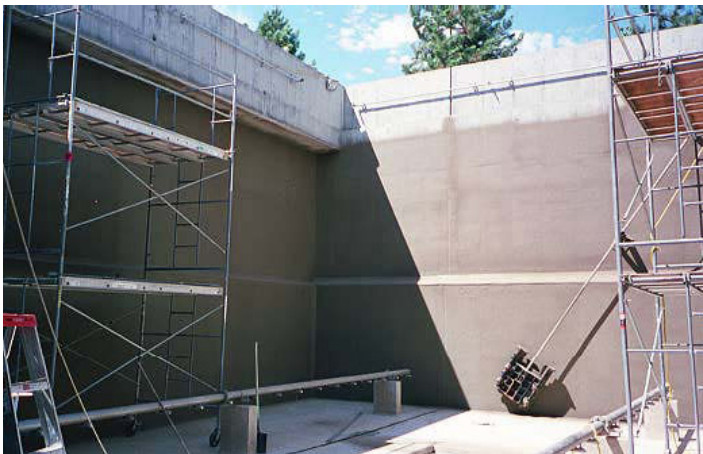
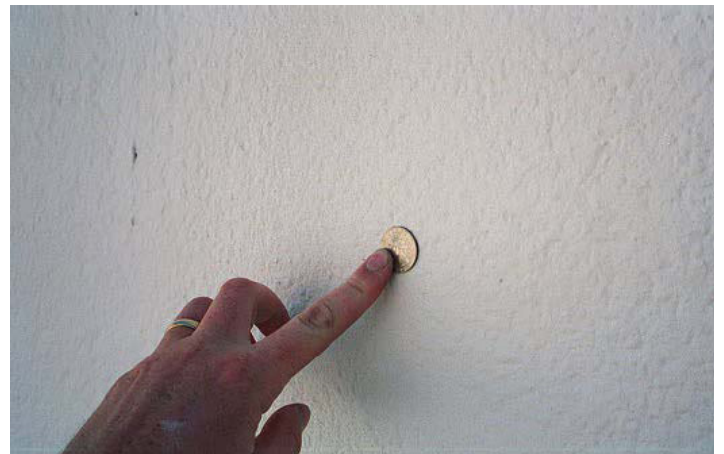
This part of the plant dates back to 1987 and consists of cast in-situ concrete. Despite several attempts to seal the kicker joint at the transition between the upper and lower wall, all have failed causing leakage and a potential contamination hazard.

Following a successful trial over the kicker, Intercrete 4842 was chosen to form a flexible, seamless waterproofing membrane to all internal faces because of its high impermeability to water, resistance to sewage and excellent crack bridging properties. Surfaces were sand blasted and pressure washed to remove contamination prior to bag rubbing with Intercrete 4822 to fill minor voids and cavities. A fillet of Intercrete 4803 was laid at the wall/floor joint to ensure this critical area was sealed. Intercrete 4842 was applied using a Graco Texspray GM1030 in 2 x 1mm coats with the first coat reinforced with Intercrete 4875 in critical areas.
