# BP Tank LN3

## Case history 2012

### Area inspected: external steelwork

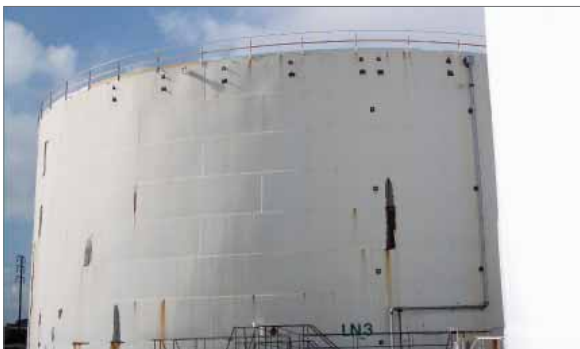
Images of tank prior being stripped clean

The tank was a complete refurbishment - old paint was ultra high blasted (minimum 30,000psi) back to bare metal and recoated as per system above.

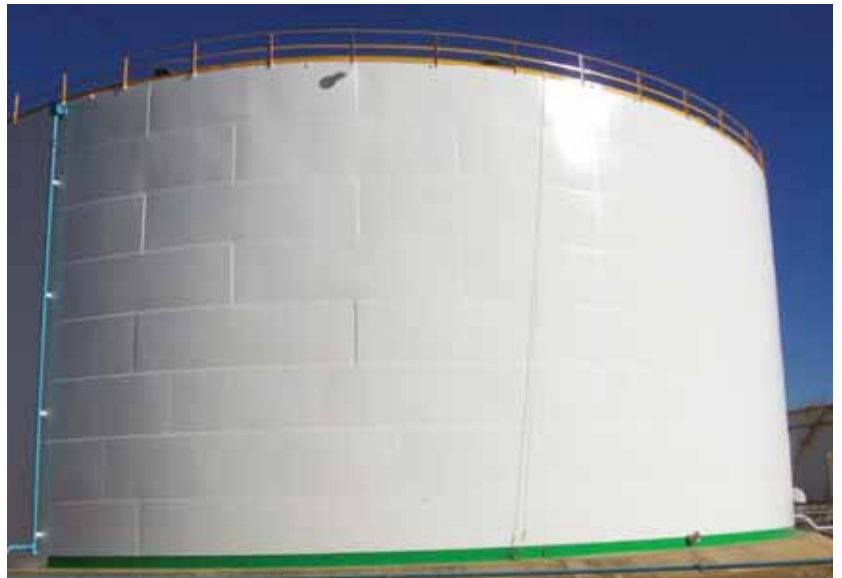
Finished tank

**“After briefly inspecting the tank late 2012 it was in excellent condition with no signs of deterioration or breakdown.”**

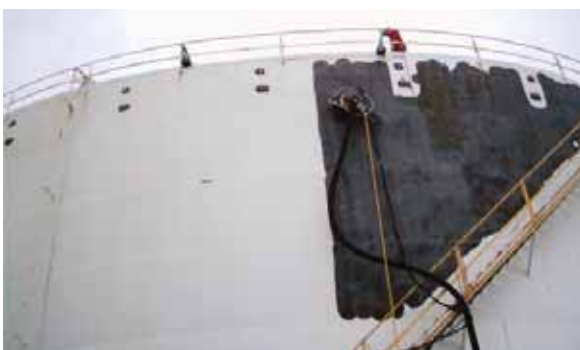
Paint removal process using UH water pressure (min. 30,000psi)
