Valero Energy tank base sealing

Case study 2012

Location: Kingsbury, Warwickshire, UK

Project owner: Valero Kingsbury Tank Terminal

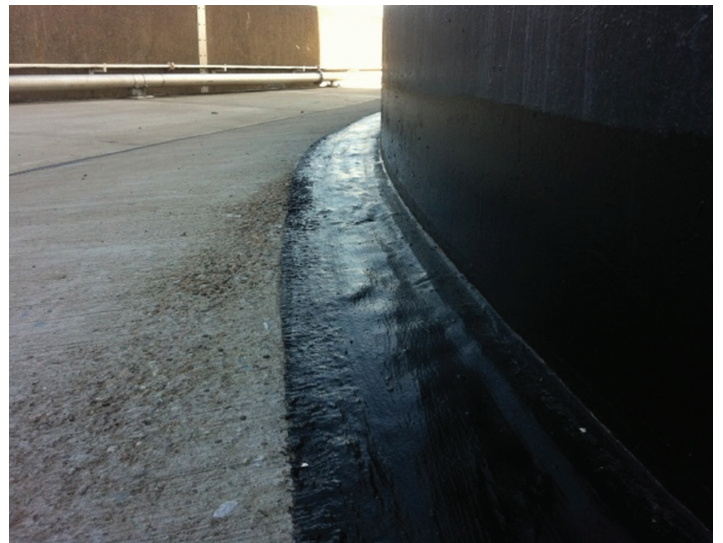
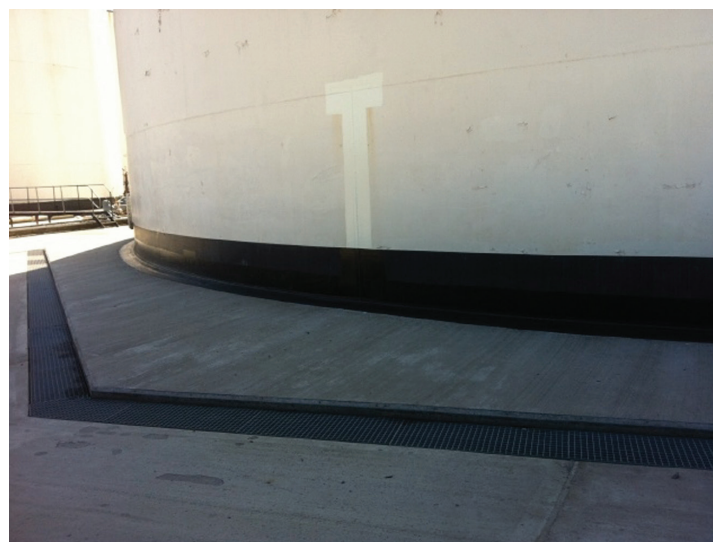
The Intercrete tank base sealing system was selected as it offers a fast, simple and cost effective solution. Intercrete 4850, waterbased acrylic primer, was applied to the concrete base to minimize the effects of out gassing. 1mm of Intercrete 4840 coating was brush applied to both the steel and concrete, then immediately after Intercrete 4872, waterproof reinforcement tape with 600% elongation, was embedded to the wet primer layer.

Intercrete 4842 was applied in 2 coats to provide a flexible waterproof cementitious coating that can resist up to +/- 10 bar water pressure ensuring a lasting solution. The following day Interfine 691 was utilized to provide a black finish as required by the owner.

Inspections have been carried out and Intercrete continues to perform. The system's ability to withstand the movement experienced when tanks are loaded and unloaded as well as the differential in thermal expansion rates between the steel tank and concrete foundation upon heating and cooling ensures it provides a lasting waterproof solution between the tank base and the concrete foundation.
