Tobago Airport aviation fuel supply line

Case study

Summary: External corrosion protection of 100mm diameter aviation fuel pipeline prior to burying

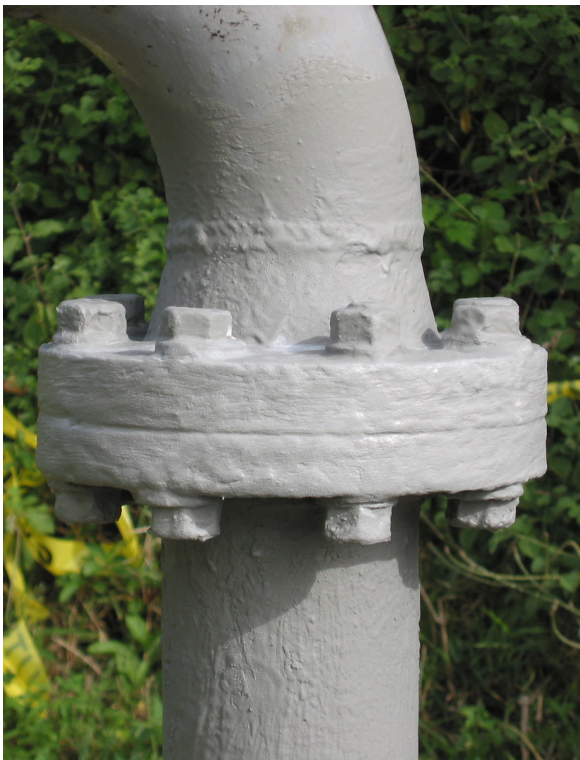
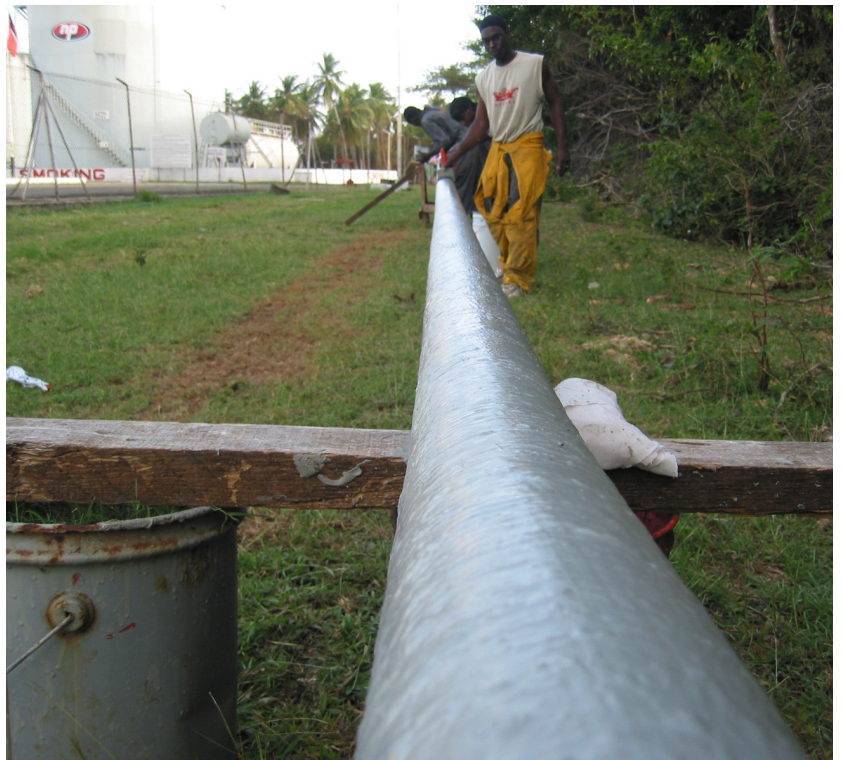
Located in soft sand in close proximity to both the coastline and swamp area, the environment is particularly aggressive leading to concern over the long term integrity of the main feed into the tank farm at Tobago Airport.

After exposing and preparing the pipeline, a 2mm layer of Intercrete 4840 was applied directly to the steel surface to provide immediate passivation. Once cured, Intercrete 4840 forms a highly durable barrier to the fuels for corrosion, blocking out water and chlorides whilst also providing enhanced chemical resistance. Intercrete 4840 exhibits good resistance to cathodic disbondment and is therefore compatible with the system which was installed. Following holiday detection testing, the pipe was inspected and buried to give many years of corrosion free life. Intercrete 4840 is water-based and therefore offers an environmentally friendly alternative to traditional coatings.
