Service reservoir roofs

Case study 2001

Summary: Repair and waterproofing of 4,000m² of concrete service reservoir roofs

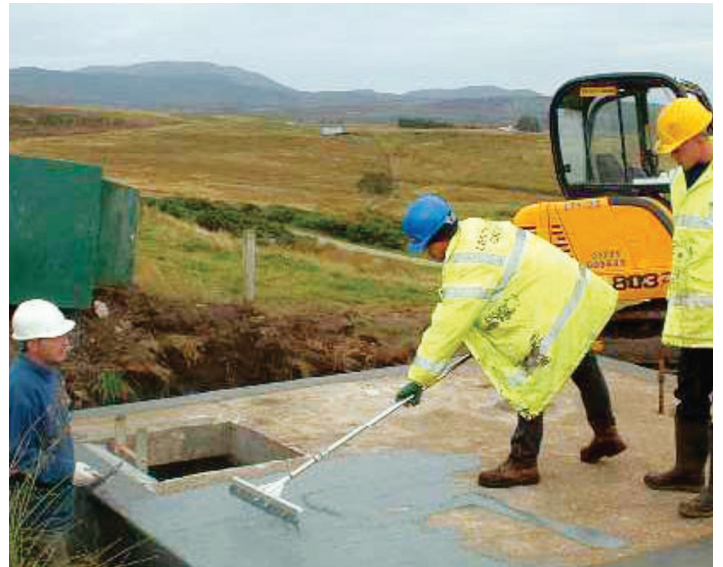
Initially, concrete repairs were completed with Intercrete 4800, an easy to use, high build hand applied mortar, whilst preparation of the surrounding surfaces was achieved with Intercrete 4820. Following this, the external roof surfaces were sealed with Intercrete 4842, a polymer cementitious coating with class-leading elastomeric properties and rapid curing characteristics. In conjunction with Reinforcing Mesh, Intercrete 4842 can be used over crazed or jointed surfaces, and, in this instance, a grit was broadcast into the surface to allow the structure to blend into the countryside, and provide a non-slip finish for foot traffic.
