Lining of waste water treatment tanks

Case study

Focus product: Intercrete® 4841

Location: Mascioni, Cuvio, Italy

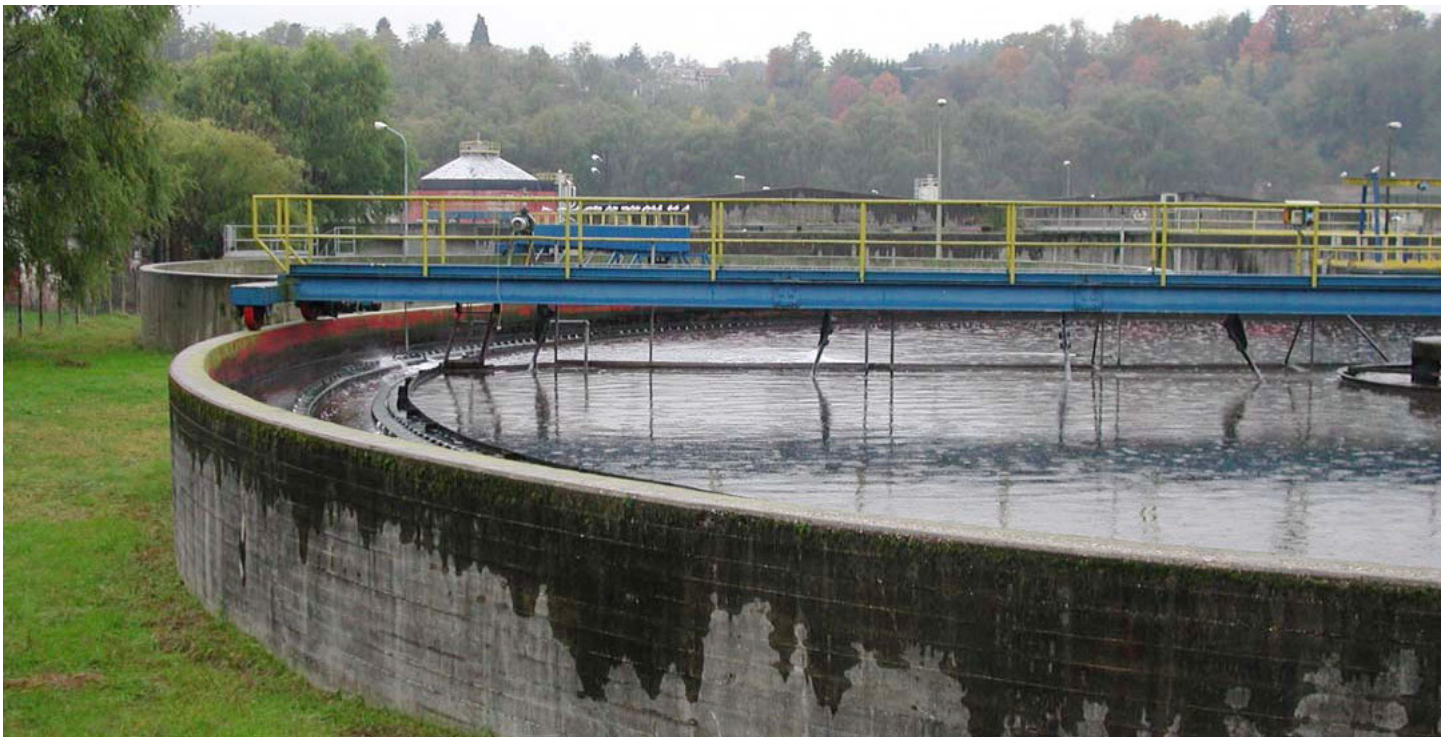
One of the main challenges is the deterioration of the large waste water tanks holding waste water from processes associated with the textile industry.

To combat the attack from the corrosive acidic chemicals, a resilient lining offering a degree of flexibility was required. One of the criteria to be met involved installation over damp surfaces and this was one of the determining factors in the coating selection. The surfaces were prepared by high pressure water lancing, which is ideal as the concrete should be left saturated, but surface dry, immediately before application. The specified system incorporated two 1mm coats of Intercrete 4841 which were applied, by spray over larger areas, or alternatively by brush techniques over smaller areas. The resultant finish provides highly durable protection for the concrete, conferring a similar level of waterproofing to an extra metre of freshly cast concrete.
