Maintenance of concrete clarifiers

Case study 2013

Location: Tasmania, Australia

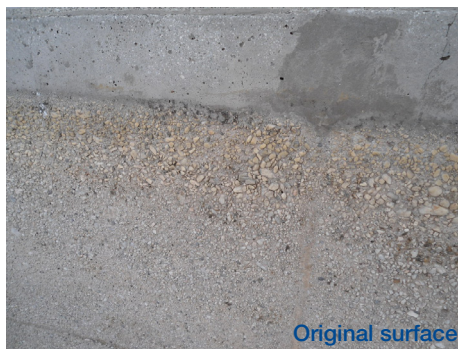
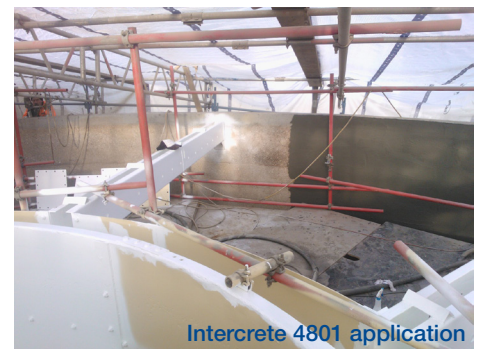
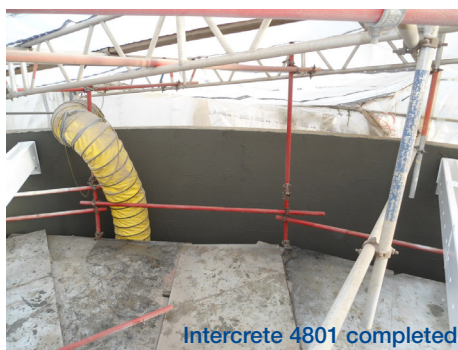
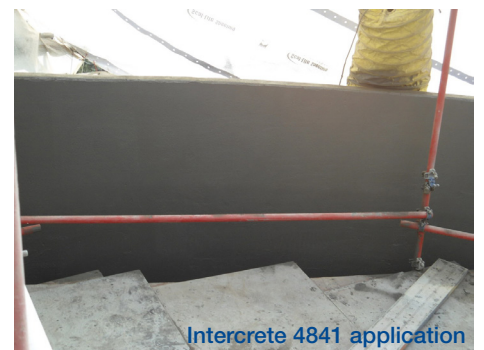
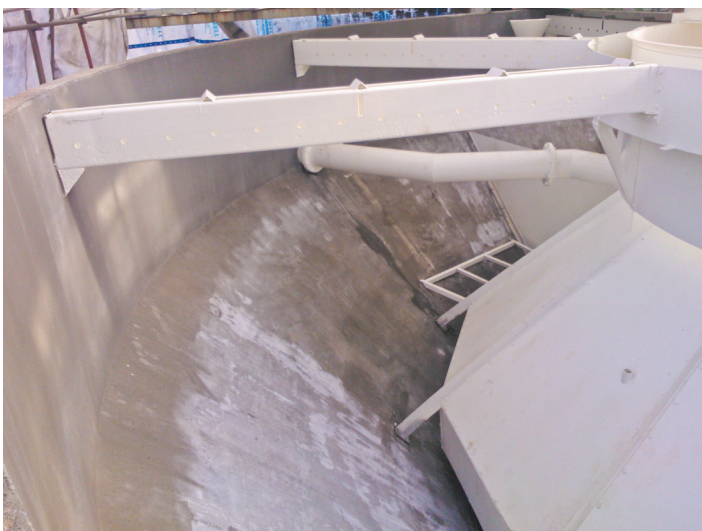
TasWater is an amalgamation of the three Tasmanian Water and Sewerage Corporations namely Ben Lomond Water, Cradle Mountain Water and Southern Water, and their service firm Onstream, formed in 2008 as a result of significant reform of Tasmania's water industry. The Ben Lomond site in Launceston, Tasmania identified two poured in-situ concrete clarifier tanks that required significant repairs to the internal face through decades of attack from Hydrogen Sulfide (H₂S). The concrete surfaces had aggregate exposed and the risk of deterioration to the reinforcing steel if left un-treated. The steel structures above the clarifiers also required re-coating as the existing protective coatings had deteriorated, exposing the steel to accelerated corrosion.

AkzoNobel offered a complete systems solution involving the protection of the steel and concrete. Intercrete 4801, high build, structural repair mortar was utilized to reinstate the degraded concrete, followed by the application of two coats of Intercrete 4841 to provide a simple, yet durable and long term protective solution. Intercrete 4841 is a two-component, polymer modified, cementitious coating with excellent resistance to carbonation and chloride ion ingress, with a 2mm application providing the equivalent of >100mm concrete cover against chloride diffusion and carbonation. Intercrete 4841 is approved for use to AS/NZS:4020 2005.
