Higashi Niigata Plant

Case history 2012

Focus product: Intersleek[®] 700 system

Asset area: Water outlet pipes

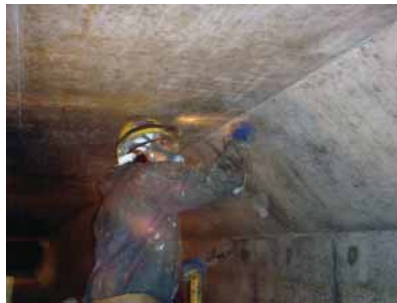
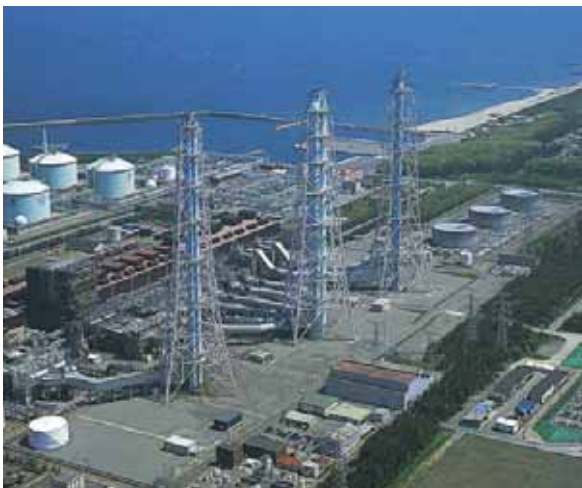
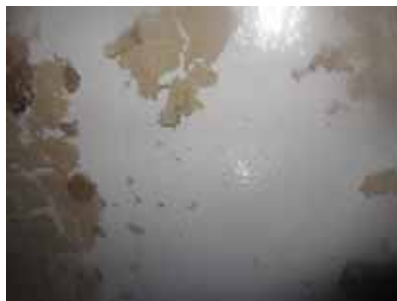
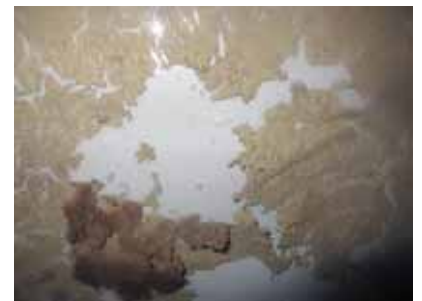
The water outlet pipes were inspected in 2012, after 7 years service, and the Intersleek system showed excellent foul release performance. There was only a thin layer of slime which could easily be cleaned off. The life of the outlet pipes before maintenance was required was extended from every 1-2 years to every 8-10 years.

System: Intergard[®] 740 @ 50µm (2 mils)
Intershield[®] 300 @ 125µm (5 mils)
Intersleek 737 @ 100µm (4 mils)
Intersleek 757 @ 150µm (6 mils)
