Leroy Merlin Commercial Centre

Case study

Summary: Repair and protection of deteriorated underground fire water storage tank

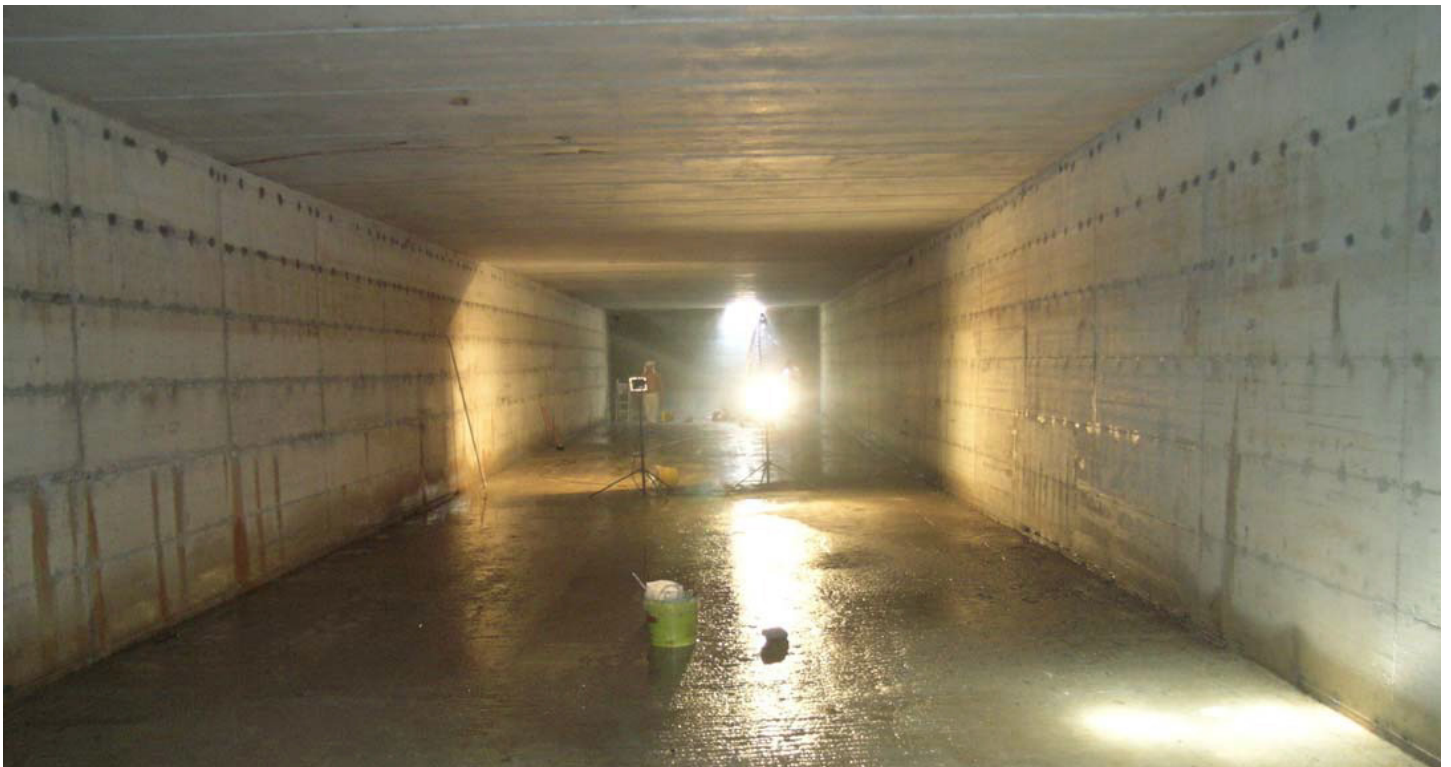
The surface of the concrete tank was badly deteriorated, with spalling and cracks resulting in water leakage. The primary requirement was to repair and waterproof the tank as quickly as possible in order to restore legal working conditions and minimise the disruption of trade.

Structural repairs to large cracks and voids were carried out with Intercrete 4800, a high strength, low density mortar, whilst superficial cavities and honeycombing were reinstated with Intercrete 4820. Subsequently the entire surface was covered with a 2mm layer of Intercrete 4841, a waterproof coating which is fully compatible with the parent concrete. Intercrete 4841 is designed for constant immersion, and being water-based it is safe and easy to apply. Once cured, it gives excellent resistance to impact and abrasion.
