Eastbourne sewage treatment works

Case study 2009

Summary: Repair and protection of underground concrete outfall tank suffering from chemical attack

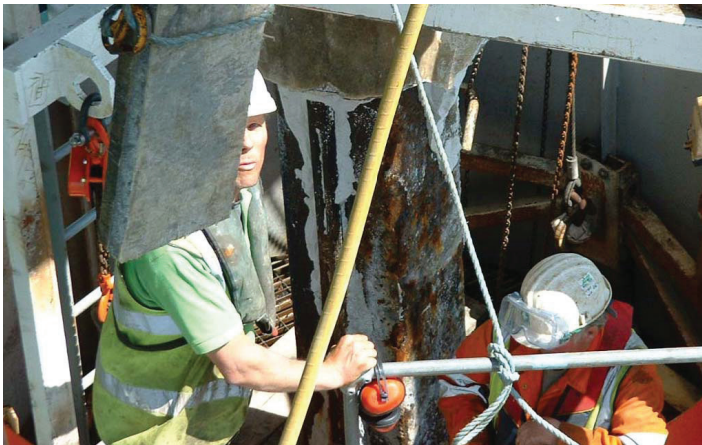
Southern Water operates 400 sewage treatment works and their facility, located on the outskirts of Eastbourne, was constructed in 1990. The reinforced concrete of the underground outfall tank was failing due to acidic and bacterial attack above the water line, necessitating a remedial programme.

In deciding upon a remedial solution, one of the requirements was to provide a high degree of chemical resistance for the concrete with a system which could be applied onto damp surfaces. Effective preparation was carried out with high pressure water following which all surface imperfections and blow holes were filled with Intercrete 4820 a cement-based polymer modified and fibre reinforced fairing coat. Intercrete 4820 is both quick to apply and highly economical in use as bagrugging technique is used. This creates an ideal surface to support a 2mm coating of Intercrete 4840, an advanced epoxy cementitious hybrid coating with excellent resistance to chemicals which would typically threaten the integrity of concrete.
