# State Route 8

## Case study

**Focus product:** Intercrete® 4842

**Summary:** Providing protection from chloride and water ingress on cracked reinforced concrete bridge columns

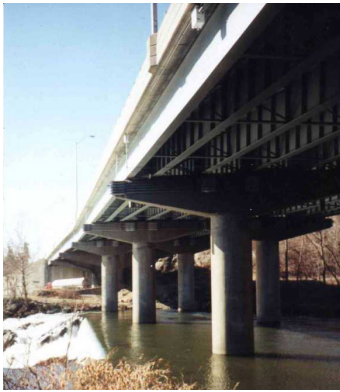
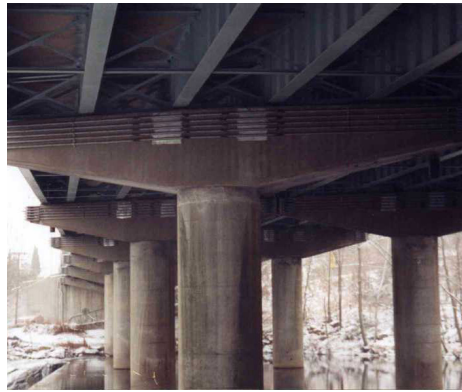
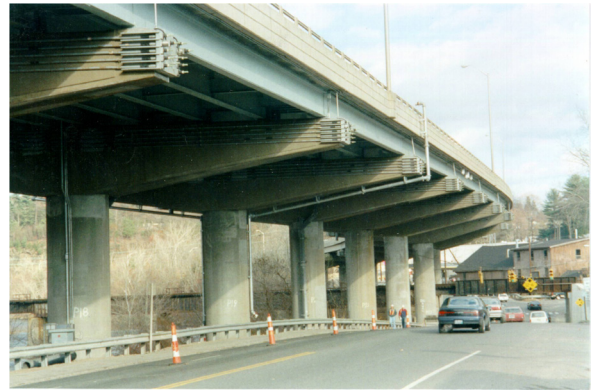
On this section of State Route 8, the supporting columns had previously been repaired with Shotcrete to replace unsound, chloride contaminated concrete.

However, this remedial work was unsuccessful, resulting in crack formation to leave the cathodic protection grid exposed to the elements. These cracks also gave ready access to moisture, carrying further chlorides into the concrete during the winter season. Urgent work was needed to assure that structural integrity could be maintained.

The minimum requirement was a coating membrane that could provide an effective flexible seal which would not become brittle over time. Intercrete 4842 was selected by the Transportation Department as it met the obvious needs in view of its excellent ability to span dynamic cracks in concrete. Intercrete 4842 is also highly waterproof, resistant to a 100 metre head of water. Also, the unique cementitious coating technology is recognised the world over for its outstanding performance in terms of resistance to chloride ion diffusion.
