# Thames Water Utilities sewers

Case study 2013

**Summary:** In-situ corrosion protection of metal sections in the sewers of London

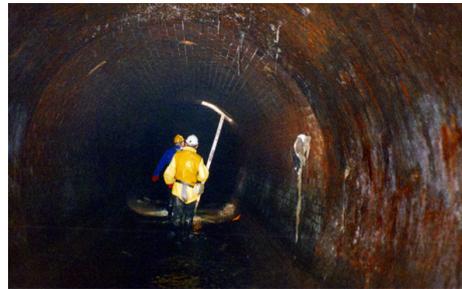
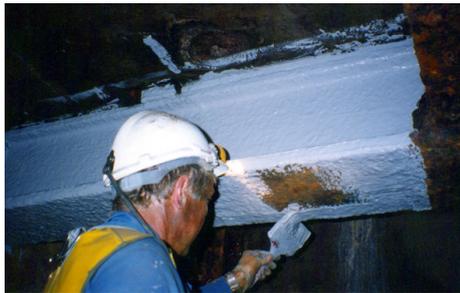
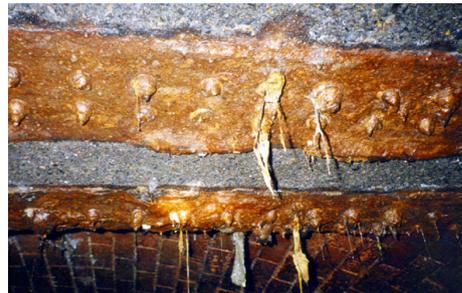
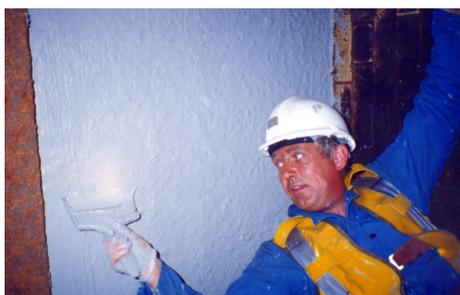
Constructed back in the 19th century, the steelwork in the main chambers of the trunk sewer in East London suffer from advanced corrosion in the permanently damp and acidic atmosphere.

Ultimately the favoured product was Intercrete 4840, an epoxy and polymer modified coating with excellent adhesion directly to steel even when there is some residual surface dampness present. To demonstrate the versatility of Intercrete 4840, varying levels of preparation were used, including needle gunning to bright metal and hand wire brushing to remove the bulk of the oxidation. Intercrete 4840 was applied by brush in two 1mm coats with the second coat placed as soon as the first was stable. The areas were then left for eight months before examination revealed that passivation had occurred, preventing further corrosion.
