Egginton Bridge

Case study

Summary: Repair and protection from chloride ingress and carbonation on a major trunk road bridge

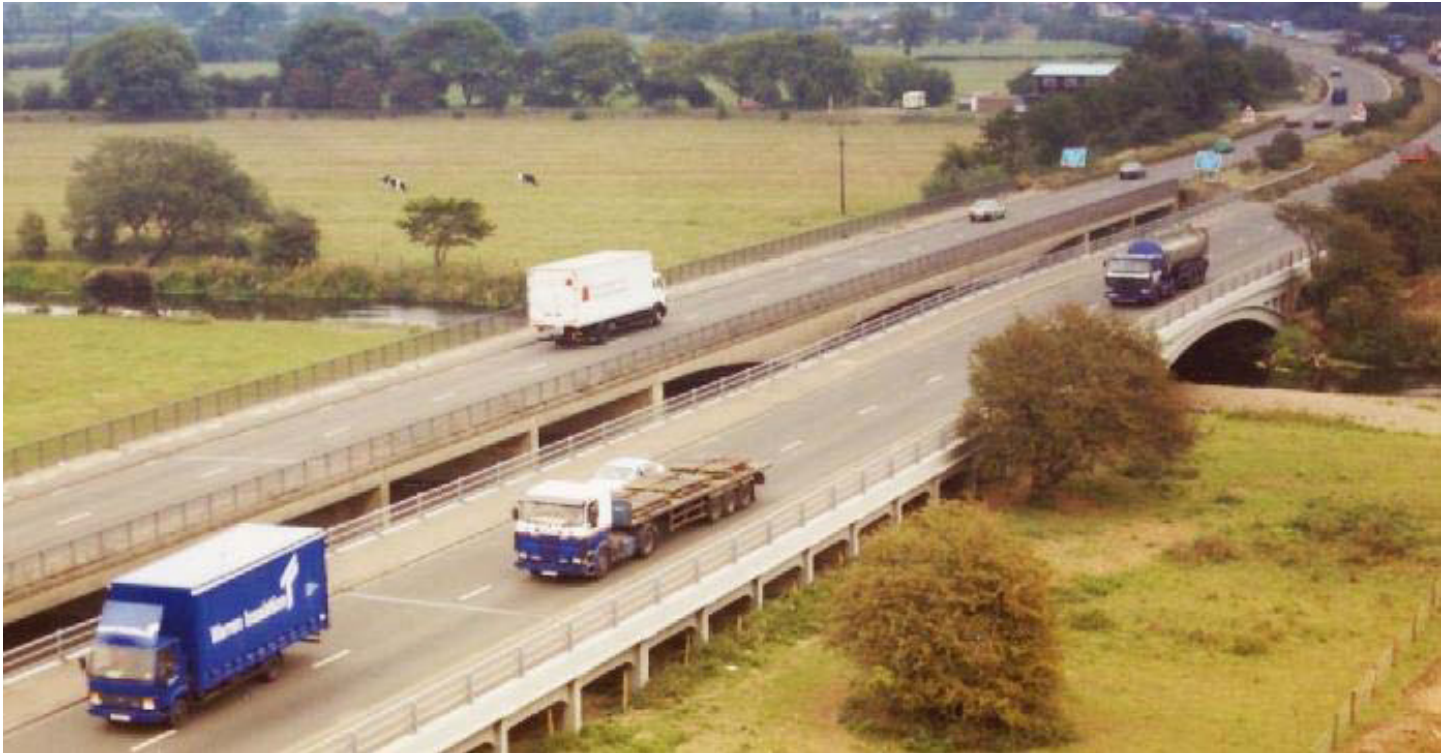
A number of damaging factors - including carbonation, chloride attack and water ingress - had caused a series of defects on the main beams, cross beams and supporting pillars. This ultimately resulted in severe corrosion of the reinforcement, creating the need for refurbishment in the Winter of 1989-1990.

Intercrete 4804 was the high strength, waterproof repair mortar used. Its low sag characteristics allowed for easy application overhead in restricted spaces. The bridge was then protected from further chloride ingress with Intercrete 4841, restoring the original appearance and producing a waterproof, anti-carbonation finish. In January 2003, Mott MacDonald, in a full assessment, found that the coating **“has performed well and there is evidence that chloride ingress and carbonation have been prevented with a re-distribution of both chloride and alkalinity... Intercrete continues to provide an effective barrier to moisture, chloride ions and carbon dioxide.”**
