Bulk storage sour water tank

Case study 1996

Focus product: Enviroline® 376F-60 glass flake lining

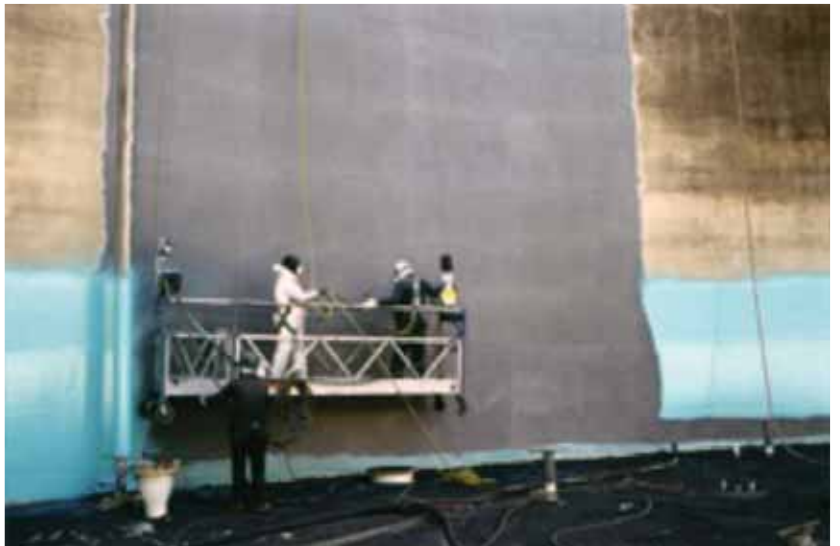
The bottom of the floating roof was blasted and lined first. The tank was then blasted and lined with a single coat of Enviroline 376F-60 at a thickness of 60 mil. Enviroline 376F-60 has excellent impact and abrasion resistance making it ideal for tanks with floating roofs. During a Taber Abrasion test Enviroline 376F-60 exhibits a loss of only 20mg compared to 150mg for conventional solvent free phenolic epoxies. Furthermore it is possible to return to immersion service within 14 hours of application, therefore the customer was able to minimise the time the tank was out of operation.
