Battle waste water treatment works

Case study 2014

Summary: Repair and chemical resistant lining to primary settlement and humus tanks

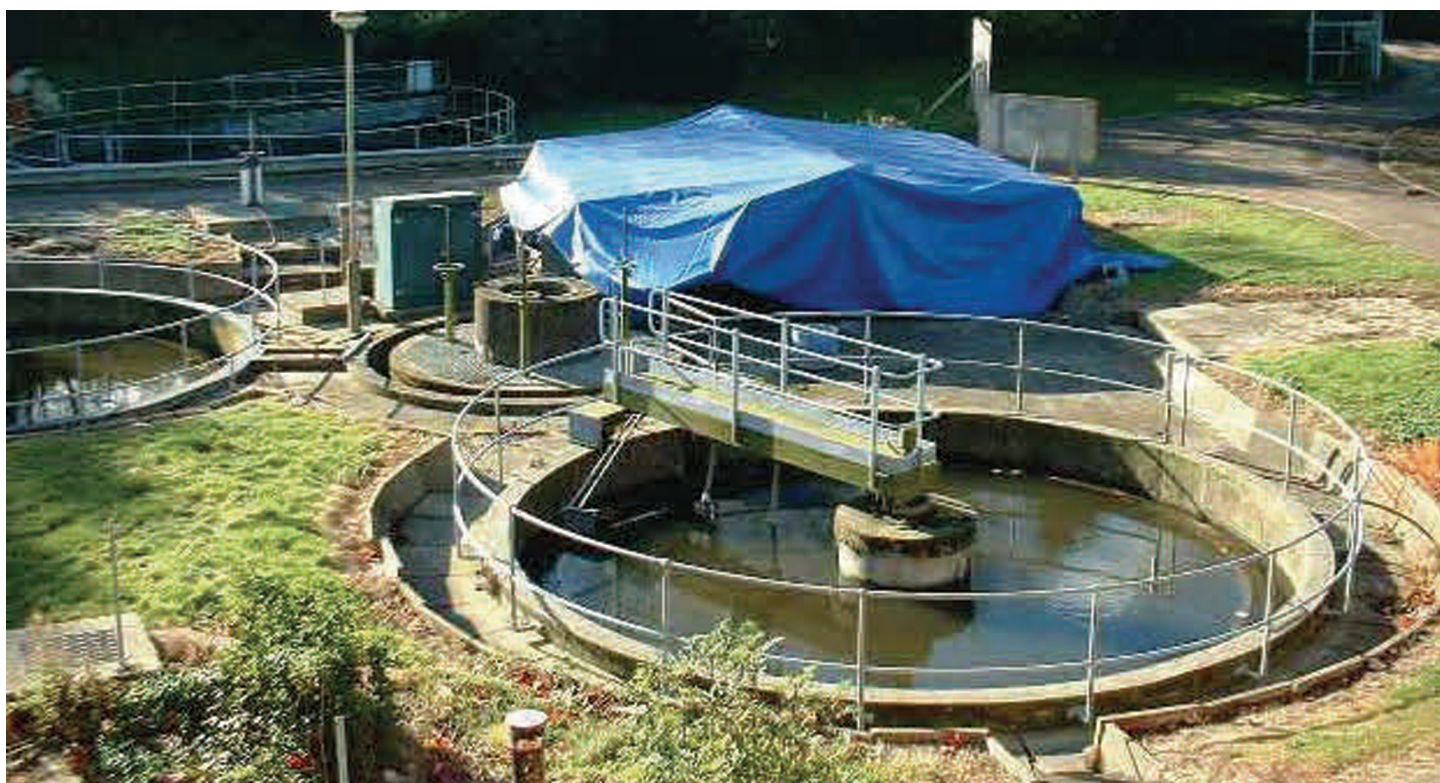
Having been in service since the 1960's the primary settlement and humus tanks at the Battle facility had been subjected to attack from the cocktail of aggressive chemicals.

Such was the extent of the damage that a full range of repair materials was needed to reinstate the integrity of the plant. Firstly, a fairing coat of Intercrete 4820 was used to level the degraded concrete, leaving a surface suitable for coating.

Where large voids were present, Intercrete 4801 technology was chosen for its high build, shrinkage compensated properties. Cracks were reinforced with mesh reinforcement embedded into a wet coat of Intercrete 4840 which was then applied overall as the final 2mm protective coating system. Intercrete 4840 is recognised for its outstanding waterproof performance and chemical resistant characteristics, significantly increasing the effective cover to the steel reinforcement.
